**INSPECTION OF CHURCHES MEASURE 1955**

**ST NICHOLAS CHURCH  
MAVESYN RIDWARE**

**February 2021**

St Nicholas Church Mavesyn Ridware  
**Diocese of Lichfield: Archdeaconry of Lichfield**  
**Quinquennial Inspection: February 2021**

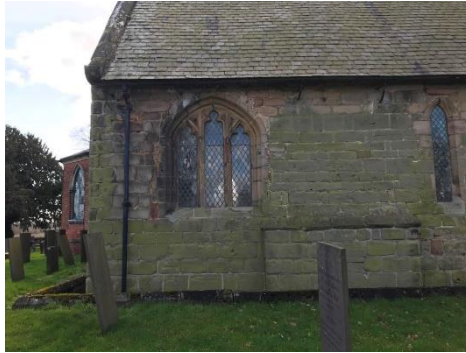
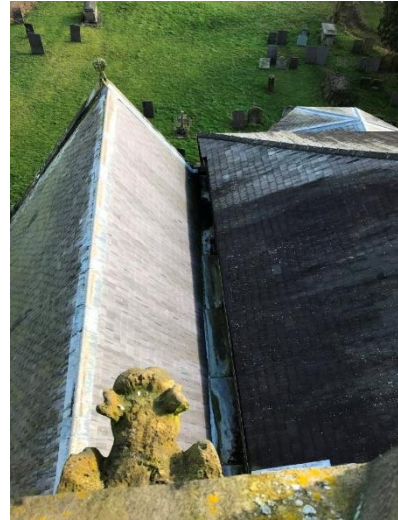
**2.1.0        Roofs**

- 2.1.1        Nave – slated tile, hips to east and west; Lead sheet hips were stolen. These have been replaced with overlapping blue clay tiles (reclaimed.) All remains in a satisfactory condition.

Leadwork valley to north aisle remains clear and in satisfactory condition.

- 2.1.2        Sanctuary– slated, lead hips, again a number of eave slates displaced, generally remains in satisfactory condition.

- 2.1.3        North aisle – steeply pitched, slate and generally firm. Mortar haunching up to parapets loose. Lead ridge patched generally poor but firm. Some loose and misplaced slates require refixing in due course. Exposed timbers appear to be sound.

Tower/Nave Valley gutter to south up to have lead in quite large sections. Remains in satisfactory condition.

- 2.1.4        Tower – stainless steel sheets to lead gutter on north side and open chute. All remains in good condition.

Lead flashings have mastic filled joints which remains in place. Conductor tape and finials to each corner. Remain well fixed.

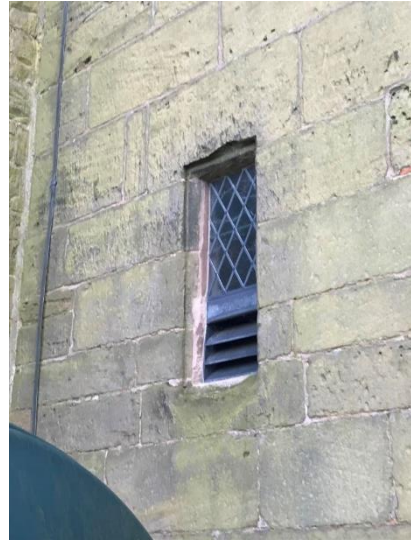
## 2.2.0 Walls

2.2.1 Generally – loadbearing brick and stone walls to the nave support and tied trussed roof; arch braced in the north aisle. There is minor movement around the sanctuary apse windows with slight cracking internally and externally. Largely due to seasonal temperature changes. The apse is a relatively small structure in terms of mass compared the 'box' nave it is attached to. No action required at present.

There is slight cracking through the large nave windows, the stone cills have split. Minor cracking, though the north aisle windows of some age.

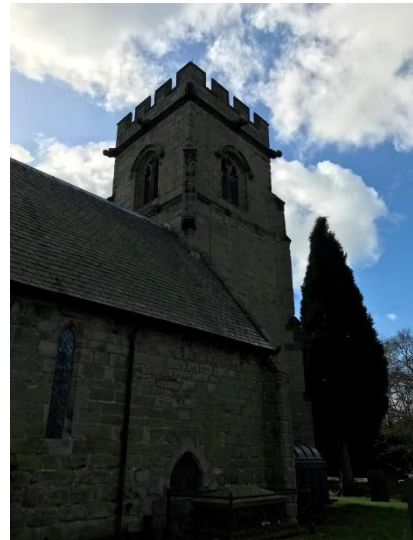
## 2.2.2 North west tower

Generally, rises to bell stage 2 light louvers, crenelated parapets, diagonal buttresses, no pinnacles the east buttresses overhang the west side roof.

Sound but the jointing is poor. Areas are deeply open much is loose and especially to the plinths and details; previous hard cement is exacerbating erosion.

Stones shaling especially west buttresses low and kid level, centre area west and bell stage generally and especially to west and east pock marked stones.

The parapets, cornice and gargoyles appear to be 19<sup>th</sup> century renewal. Eroded joint but sound, open joints in the cornice. Renewed louvre blades, oak. Conductor strip to west.

1.	A phased program of external repointing and repairs to the stonework. North aisle and tower.	£7,500
<b>8.4</b>	<b>Works to be considered beyond the Quinquennium</b>

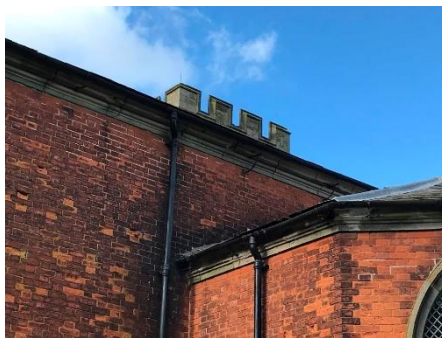
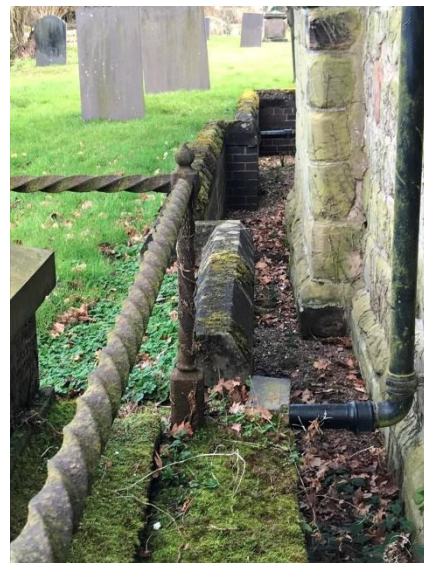
### 2.3.0 Rainwater Goods

- 2.3.1 Pipes and gutters cast iron and generally appear of some age but suffering accumulation of debris. Fibreglass pipe to east reasonably sound but tight to wall. The gutters are generally set on extended brackets which are well below the roofing slate eave. Down pipes generally set on extended brackets which are well below the roofing slate eaves.

Downpipes generally enter ground without gullies. All are cast iron apart from box downpipe at the east end of the main nave/north aisle lead sheet valley gutter.

Gullies sealed covers to tops on north side. Grille missing east end of valley and choked.

2.	Clear cast iron gutters and downpipes annually. This needs to be undertaken with care.	£1,500
<b>8.2</b>	<b>Works to be carried out within the 18 months</b>

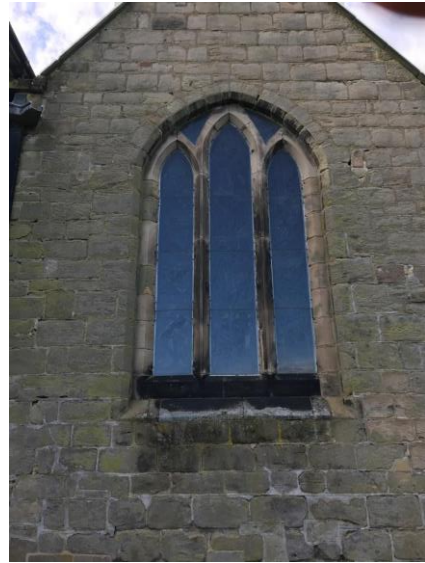
#### **2.4.0 Windows**

Generally, all leaded glazing into stone frames and tracery.

- 2.4.1 Nave – leaded in rectangles in large panels. Some distortions. Internal steel armatures corroded.
- 2.4.2 Chancel – very small, tinted diamonds, distorted severely to south and centre bar corroded. Previously releaded casement to north east iron frame corroded.
- 2.4.3 North aisle – stained glass to east, lated externally. No ventilation, severe distortion. Diamonds to north firm but 'repaired'.
- 2.4.4 Tower – small window to north. Part leaded louvre below. Metal frames to west. All sound.

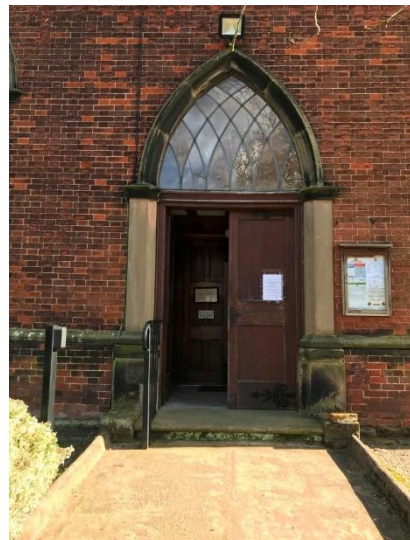
#### **2.5.0 Doors**

- 2.5.1 Nave west panelled modern applied face hinges. Some shrinkage in panels and joints.

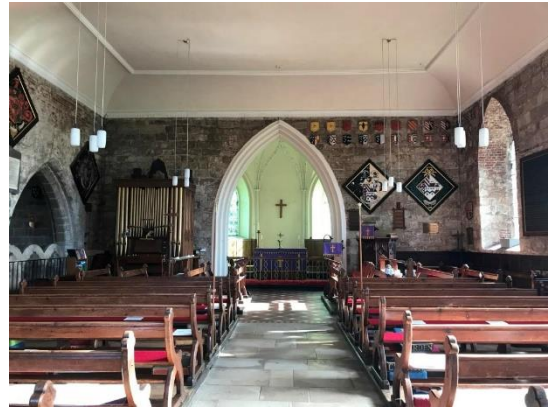
**3.1.0 Roofs/ceiling**

3.1.1 Nave – plastered. Simple detailed cornice cove and reeded bed mould. Old cracking below paintwork. Generally satisfactory condition.

3.1.2 Sanctuary apse – a plaster vault enlivened with ribs and crocketed ogee arches. Old cracking adjacent to windows and rising into vault.

3.1.3 North aisle – plastered below arch braced rafters. Cracks mid-level to south and west where partition removed.

3.1.4 Tower – plasterboard spalling to nail fixings.

3.1.5 Bell chamber – modern joists and boards. Rusting north-south steel beam.

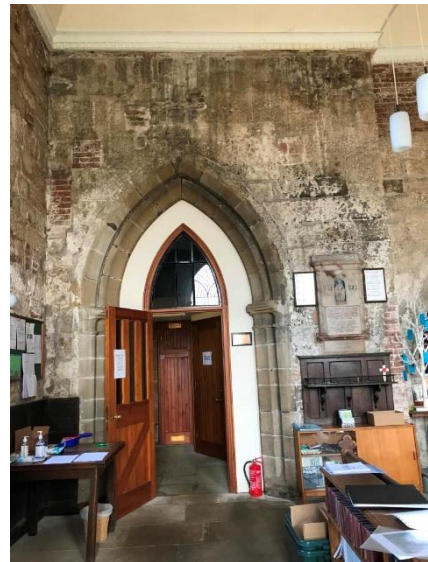
**3.2.0 Walls**

3.2.1 Nave – stonework rising to brickwork to north over the arcade and above the window arches and reveals. All stripped of original plaster. All remains in good condition.

3.2.2 Tower - patching and stains to west tower wall. Stonework eroded below louvres at high level and to arches in ringing chamber.

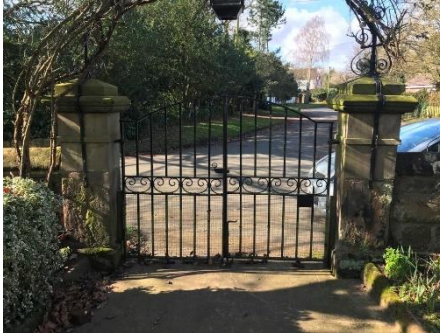
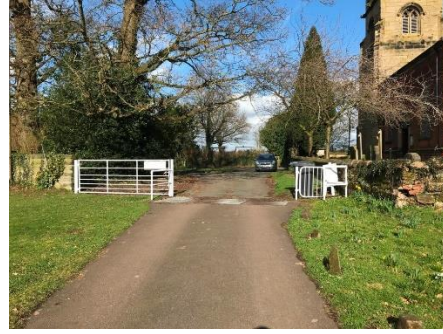
## 7.0.0 Paths and Boundaries

- 7.1.0 Generally extensive and well maintained. There are a number of leaning stones and several damaged tombs with ivy and corroding ironwork. There is a loose slab to south east. Main west pathway is wide, and level made from concrete wide gravel path is laid across the southside of the church. Boundary walls remain stable; however, the south side boundary wall is in poor condition and is failing around the south west corner of the churchyard. Trees and shrubs are well maintained.

- 7.1.1 Various mature trees including a pine and cypress south of the nave, too close? There is an ancient Yew to the east and an oak tree on adjacent land is leaning over the churchyard. Check dead branches.

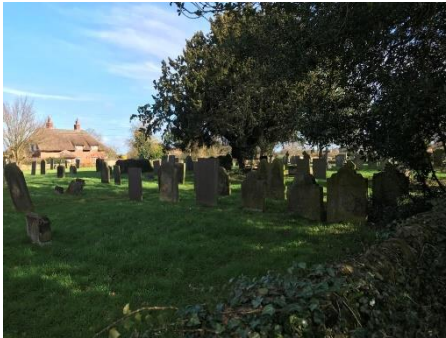
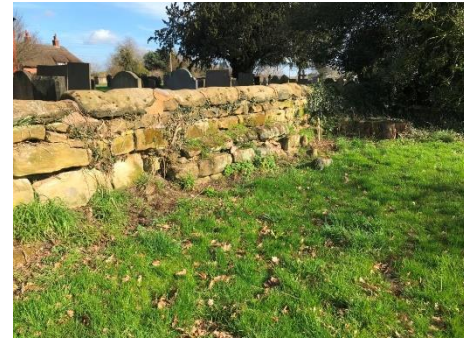
- 7.1.2 Boundary walls are stonework. Areas to the south becoming poor and deeply open jointed to north. Some patch pointing.
- 7.1.3 Path to west gate is concrete and eroded. Iron gates to west. To the north east poor and corroding.

2.	Carry out mortar repairs to the south boundary walls. This should be carried out with care and the stone walling is ancient.	£10K
<b>8.6</b>	<b>Archaeological issues</b>
