VISIT TO THE CHURCH OF ST NICHOLAS, MAVESYN RIDWARE
17th AUGUST 2023

Church Electrical Installation

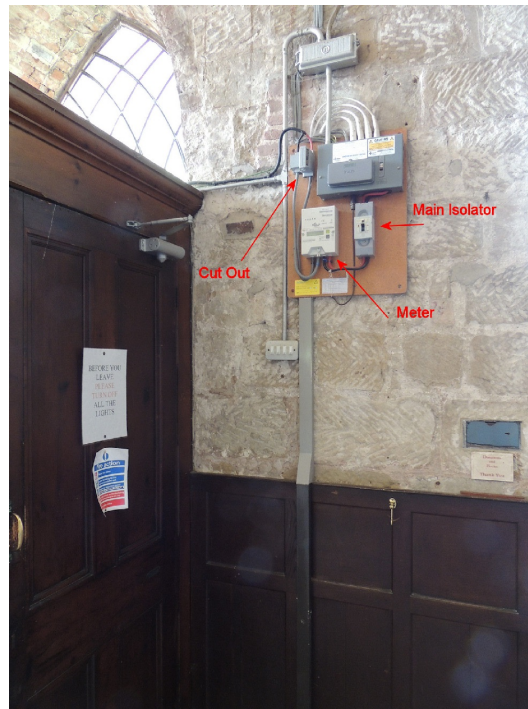
3. The church has recently had its 5 yearly electrical test and inspection and was concerned by the results. The key issue was the size of the main isolator and meter tail cables. The electrical supply is an overhead one with the church having its own earth rod. It was common for this type of supply to have a smaller than usual size of fuse in the supply, commonly 100 amp but in cases like St Nicholas, often smaller at 80 amps. It is not possible to determine the size of fuse with out removing it and inspecting. Thus it is probable that the electrician presumed that the installation had a 100 amp fuse in its cut out. But, as is more probable as the original installation would not have had a test certificate on completion, it is more likely that the cut out only has a 80 amp fuse. See picture below. If this is the case, which can easily be proved by

removing the fuse, then most of the comments in the Test and Inspection report are not valid.

Electrical supply and fuse board

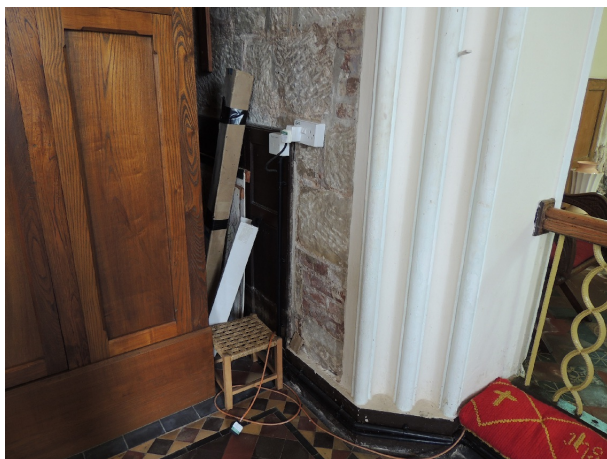
Socket outlet adjacent to the organ

4. However there are several other issues that ought to be resolved.
5. There is a socket outlet over the sink in the kitchen. This must be protected by a 32mA RCD in the fuse board.
6. The MICC in the North Chapel has external corrosion and has very low impedance readings. This may cause problems in the near future, not least nuisance tripping of the main RCD. Therefore the parish ought to consider replacing this cable as soon as possible.
7. The socket outlet adjacent to the organ ought to be at low level.
8. The socket outlet ring circuit should be extended from adjacent to the organ across the chancel step to new socket outlets adjacent to the pulpit. Note that the pulpit light is supply via a 2 amp socket which does not have a fuse, this ought to be replaced by a 13 amp socket outlet and the plug top have a 2 amp fuse fitted for the light.

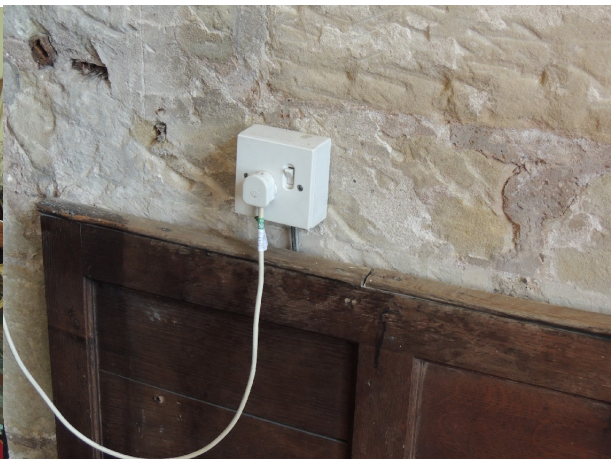
2 amp socket outlet by pulpit

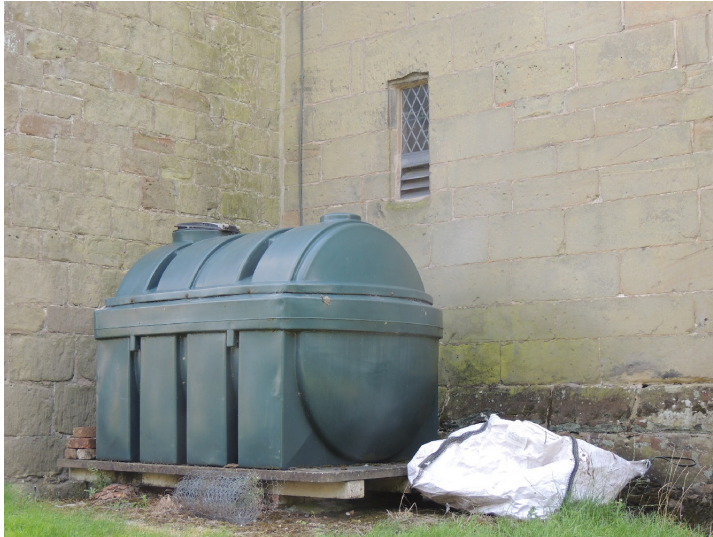
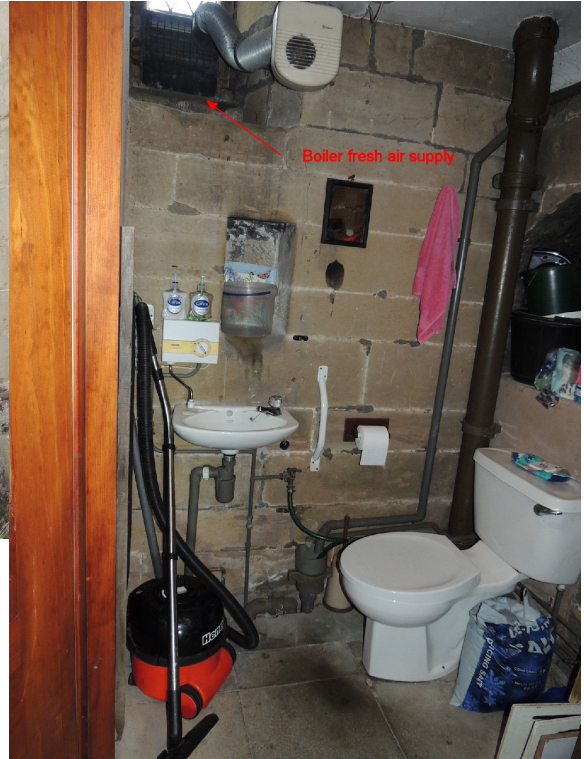
9. The existing fuse board has cartridge fuses, which the parish has no spares. It is also too high for emergency access. Therefore it would be most convenient if the fuse board was replaced with a modern MCB distribution board. The board should have sufficient ways so that each final circuit has its own MCB. The socket outlet circuit should have combined RCD/MCBs for earth fault protection. But to prevent large earth faults tripping both the final circuit RCD and the main supply RCD, the main RCD should have a short, 100 milli-second, delay. The parish should also considered moving the distribution board to a more convenient height.
10. While there it was noted that the toilet is in the same room as the oil fired boiler. The toilet extract discharges onto the boiler fresh air supply grill, see pictures below.

11. The simplest answer is probably to remove the extract fan.
