**INSPECTION OF CHURCHES MEASURE 1955**

**ST NICHOLAS CHURCH  
MAVESYN RIDWARE**

**February 2021**

St Nicholas Church Mavesyn Ridware  
**Diocese of Lichfield: Archdeaconry of Lichfield**  
**Quinquennial Inspection: February 2021**

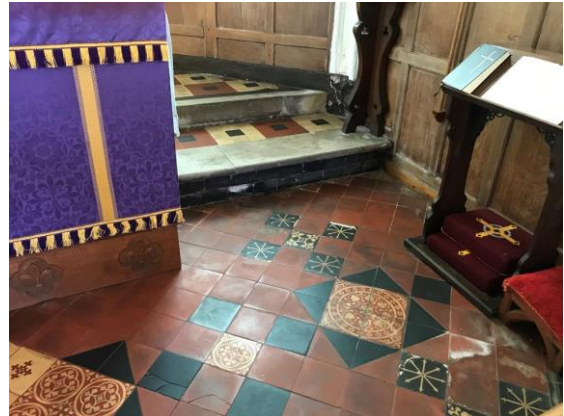
- 3.3.1 Nave below tower – stone paving to walkways.
- 3.3.2 19<sup>th</sup> century ceramic tiling below choir stalls.
- 3.3.3 Sanctuary apse 18<sup>th</sup> century tiling with hard sandstone step edges at nave/sanctuary arch and up to high altar position.
- 3.3.4 North aisle 18<sup>th</sup>/19<sup>th</sup> century terracotta large format tile – upper section – lower section (technically a crypt chapel) patterned stone slabs are late medieval tiles and alabaster memorial slab stone steps down to the crypt chapel.

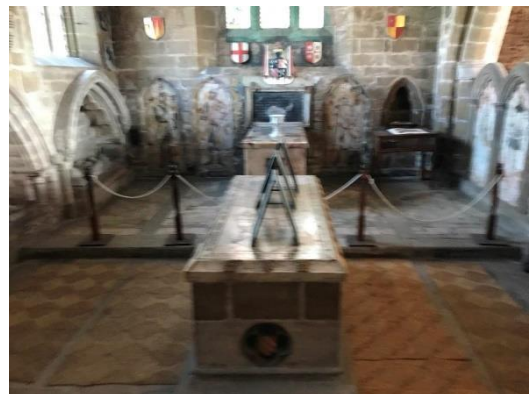
- 4.1.0 In the north aisle: - there are two recessed tombs with effigies in the north wall. Two chest tombs alabaster and sandstone. Various hatchments previously restored and more to be restored within the north aisle.

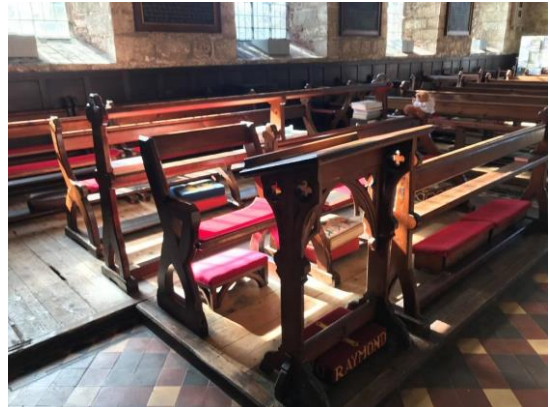
- 4.1.2 Seating consists of open pine benches and stalls.

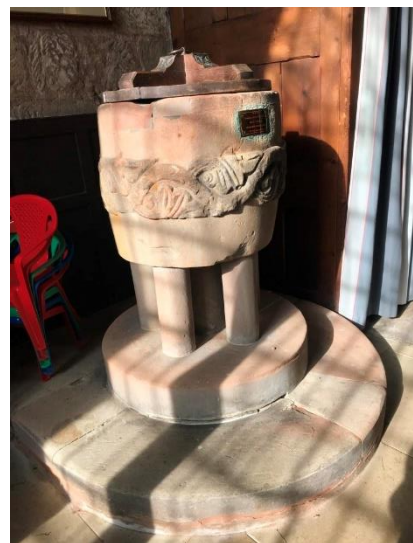
- 4.1.4 There is a 12<sup>th</sup> century decorated stone font with sculpture bowl with a heavy oak cover. There is some damage. Possibly recarved Saxon tub font.

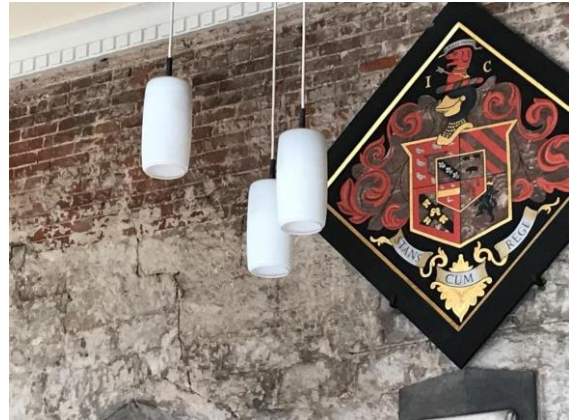
Wired in a mix of PVC sheathed and bare copper MICC and PVC-PVC cable. Note switches and sockets adjacent to sink, must be used with great care.  
last test by Andrews Electrical, Alrewas 27/01/2017 next due 27/01/2022.

Lighting is via 6no. triple pendants in the nave. Various spotlight fittings to north aisle and sanctuary apse. Fluorescent fittings to kitchenette, WC and tower.

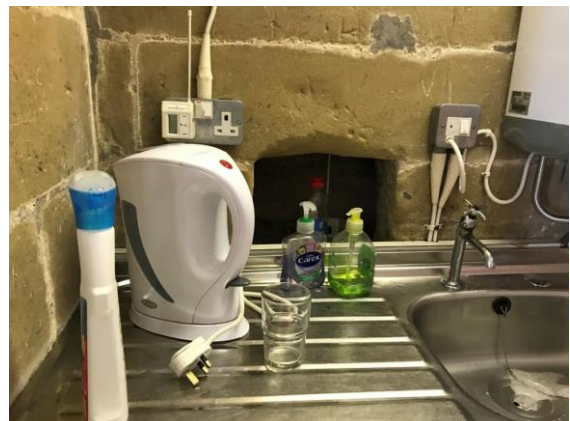
6.3.1 Power sockets close to sink are illegal and must be used with care.
